Document ID: IK0400077
Revision: 8
Created: 4/11/2011
Last Modified: 5/22/2013
Author: Anthony Kelso

Title: FLR-10 and FLR-20 Bendix Wingman fault.ACB display with SPN 886 FMI 7. Includes procedures for repeat misalignment failures on FLR-10 Radars

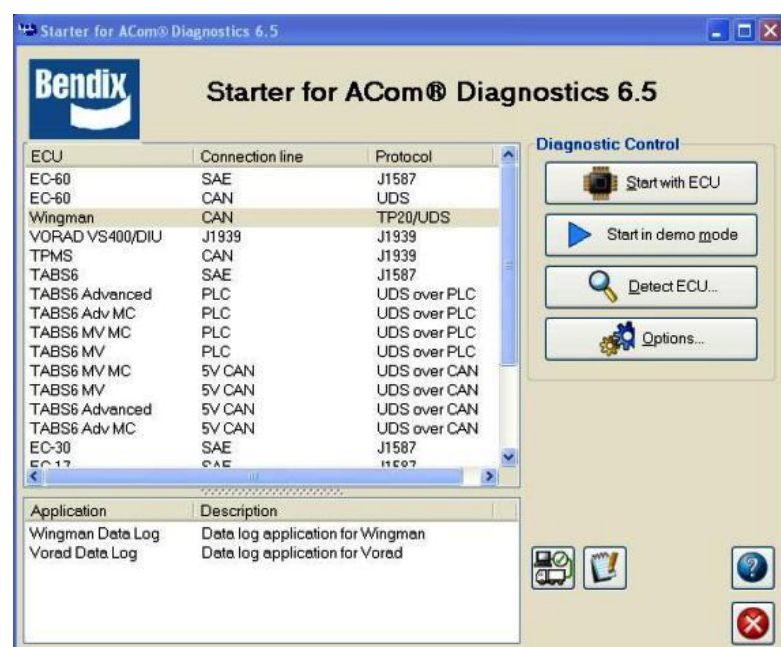
If the system generates a Diagnostic Trouble Code, where a lamp or icon is illuminated on the instrument cluster, then ACOM Diagnostics software – version 6.5 or later – is required. **Select "ACB" from the starter screen(1)**, then "Start

with ECU" (2) . Click "DTC" to show the diagnostic trouble codes.
